**TRANSPORTATION SCIENCES  
CRASH DATA RESEARCH CENTER**

Veridian Engineering  
Calspan Operations  
Buffalo, New York 14225

**CALSPAN ON-SITE AIR BAG RELATED CHILD FATALITY INVESTIGATION  
CALSPAN CASE NO. CA96-010  
VEHICLE - 1996 DODGE CARAVAN SE  
LOCATION - TENNESSEE  
CRASH DATE - 1996**

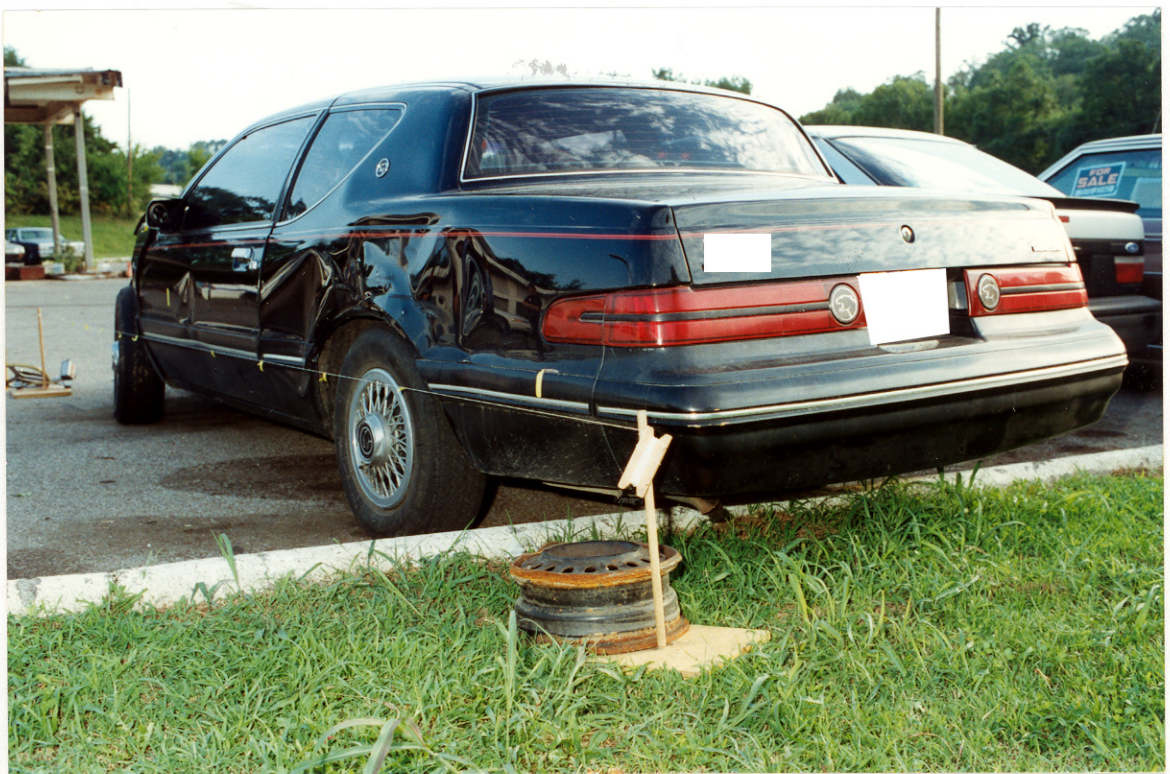
The secondary sideslap damage was minor with a maximum crush of 4.8 cm (1.9 in) located 17.1 cm (6.75 in) forward of the left rear axle. The direct contact damage began 81.3 cm (32.0 in) rearward of the left rear axle and extended 245.1 cm (96.5 in) forward. The crush profile for the sideslap was as follows: C1=0 cm, C2=3.3 cm (1.3 in), C3=4.8 cm (1.9 in), C4=0.6 cm (0.3 in), C5=0.3 cm (0.1 in), C6=0 cm. The left side rear view mirror, located 91.4 cm (36.0 in) rearward of the left front axle, was fractured by the secondary impact.

112. Left side view of the secondary (side slap) damage.
